**JOHNSON CONTROLS, INC.
FOWLERVILLE, MI
EPA ID NO. MID099124299**

**FIELD OVERSIGHT REPORT
FOR PHASE III RFI FIELD ACTIVITIES**

FIELD OVERSIGHT REPORT
FOR PHASE III RFI FIELD ACTIVITIES

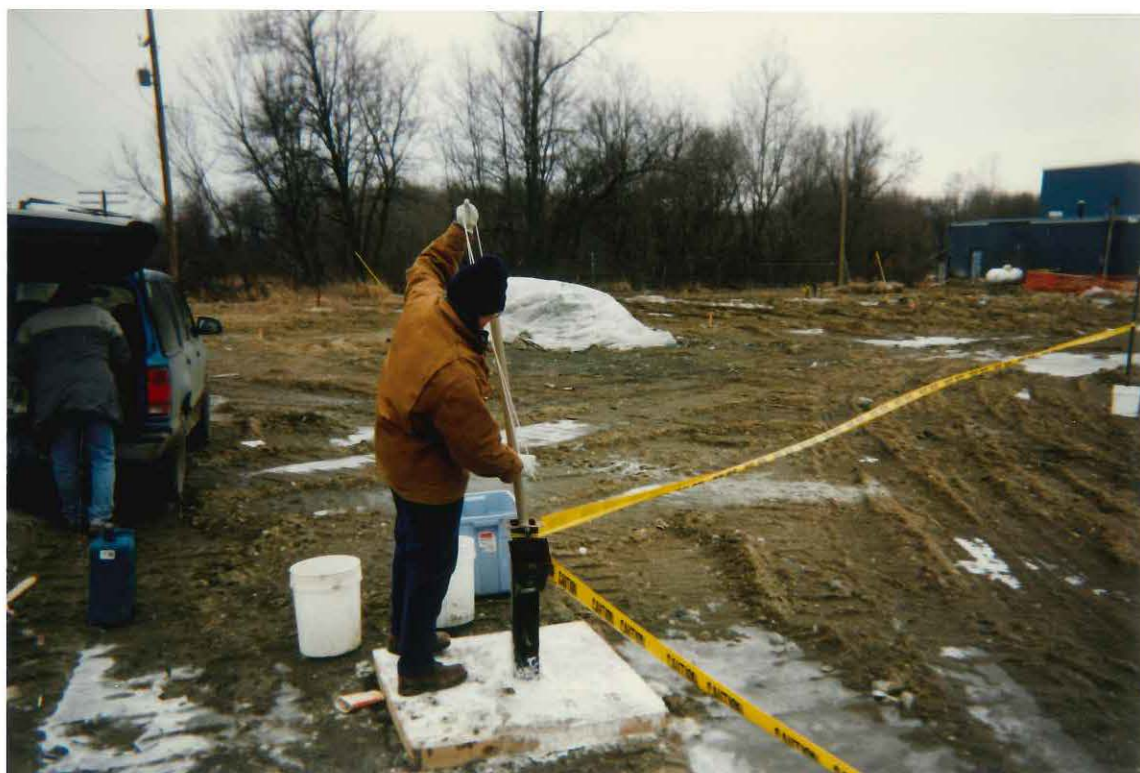
PHOTOGRAPH #83

LOCATION:	Stanley Tools, Fowlerville, MI
DATE:	2/22/94
TIME:	1603
SUBJECT:	Christina Ohel of D&M purging well MW-K1.

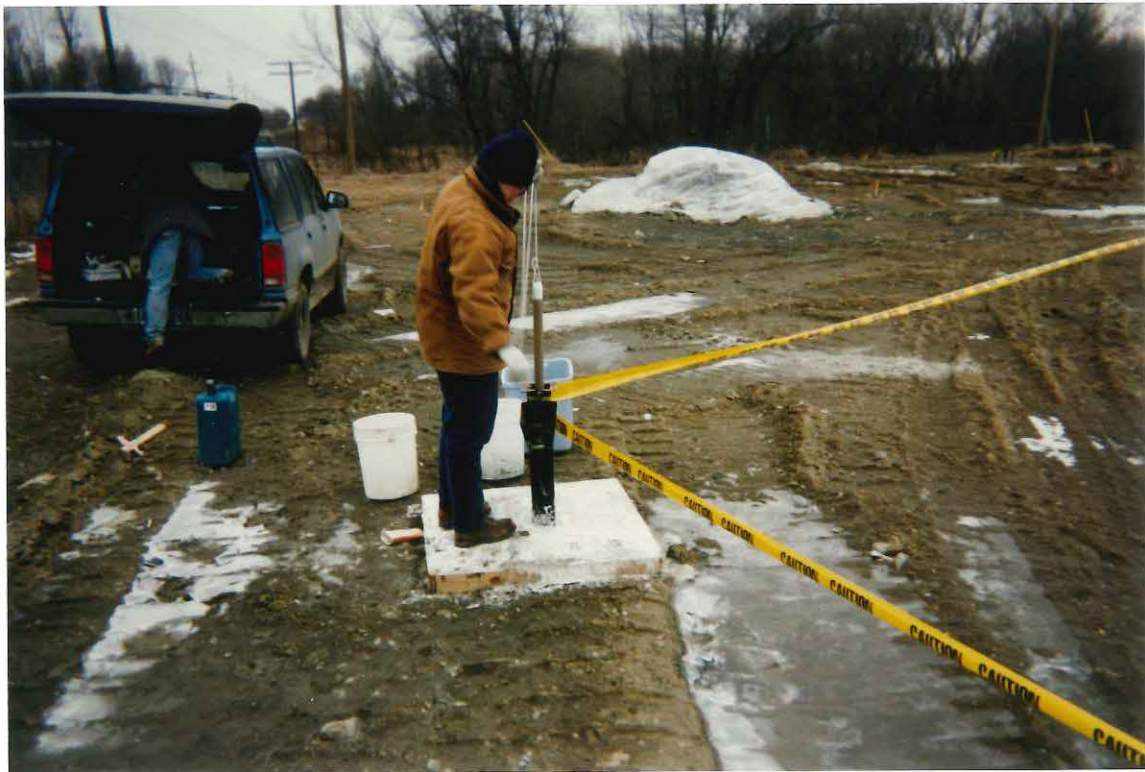
PHOTOGRAPH #84

LOCATION:	Stanley Tools, Fowlerville, MI
DATE:	2/22/94
TIME:	1603
SUBJECT:	Christina Ohel of D&M purging well MW-K1.

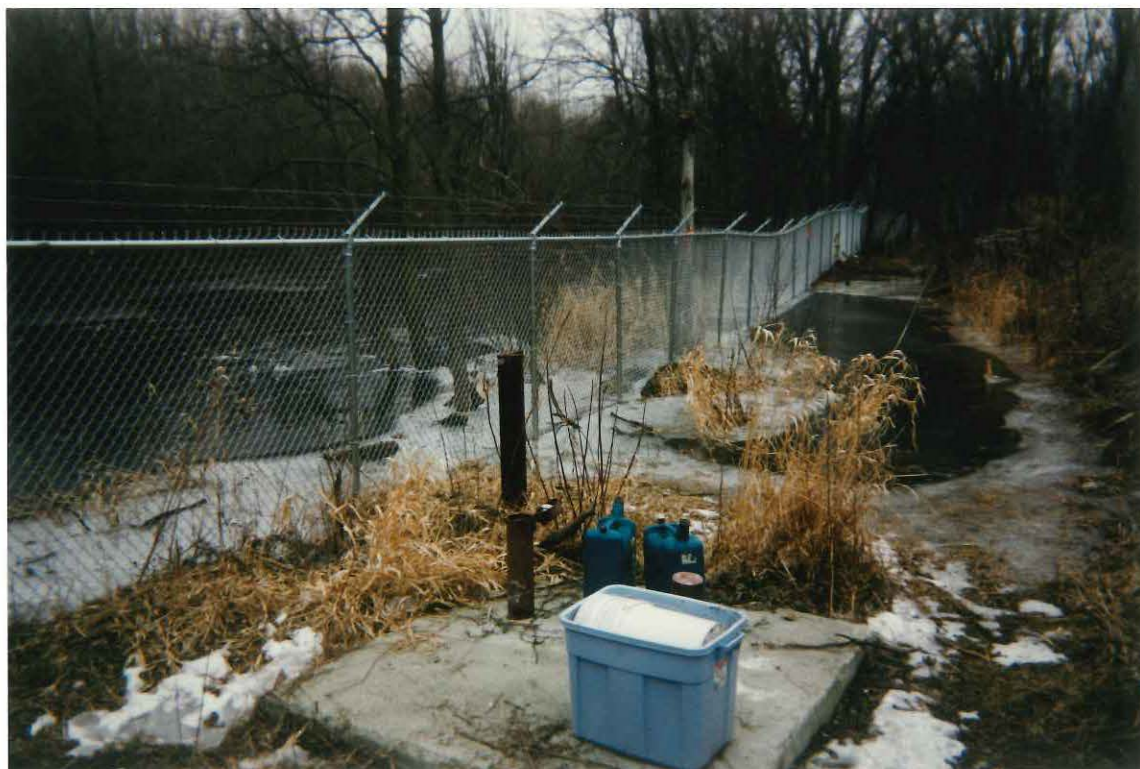
PHOTOGRAPH #85

Wells MW-F's, well MW-F3 is open. Red Cedar
River in background is flooded to Unit F.

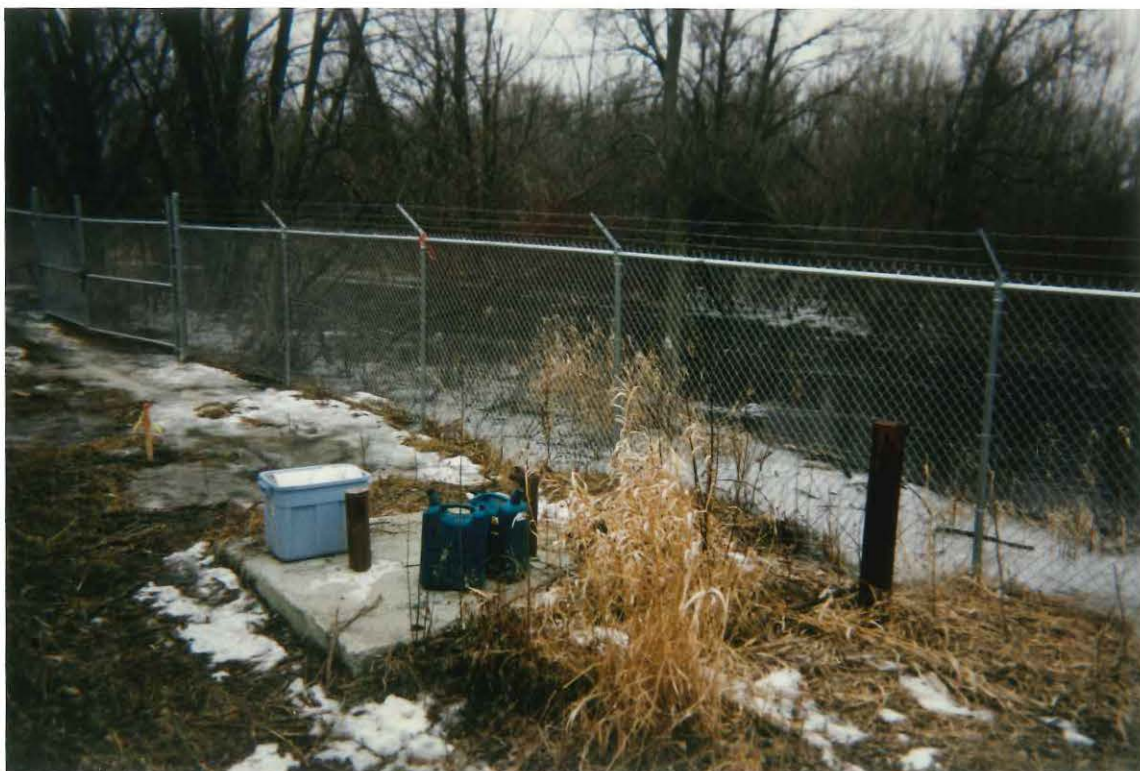
PHOTOGRAPH #86

LOCATION:	Stanley Tools, Fowlerville, MI
DATE:	2/22/94
TIME:	1648
SUBJECT:	Wells MW-F's with Red Cedar River in background. View looking south.

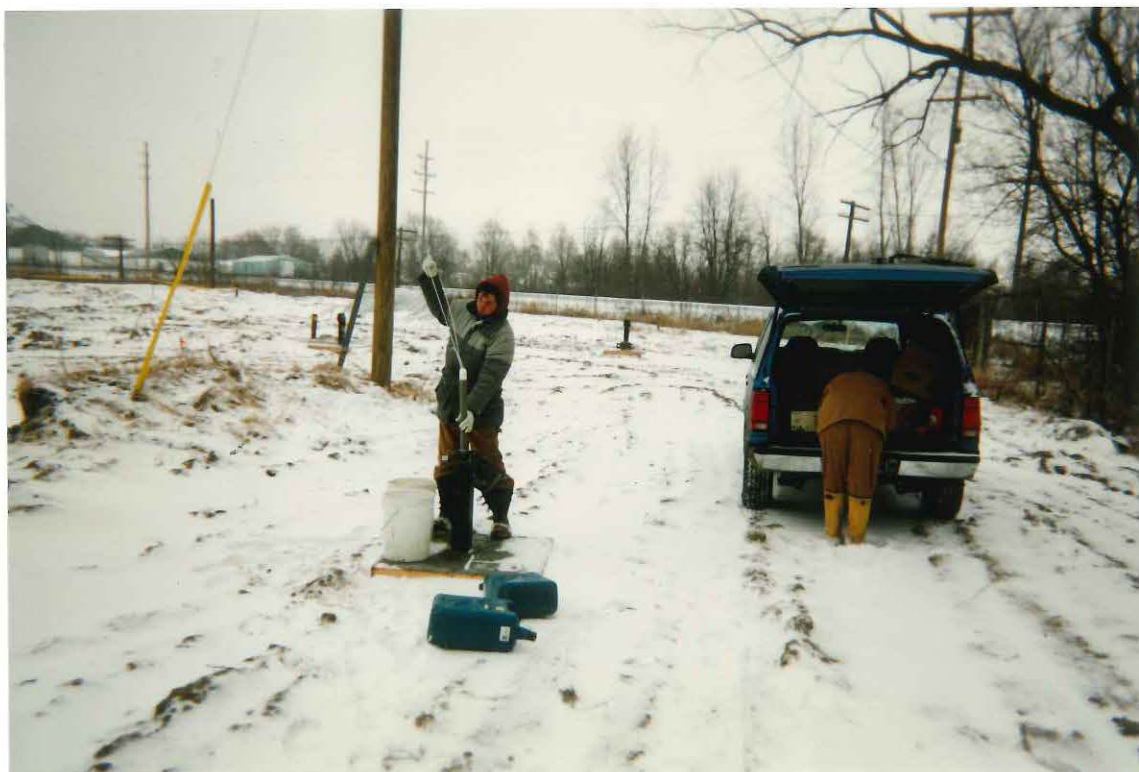
PHOTOGRAPH #87

LOCATION:	Stanley Tools, Fowlerville, MI
DATE:	2/23/94
TIME:	1100
SUBJECT:	Purging well MW-J4.

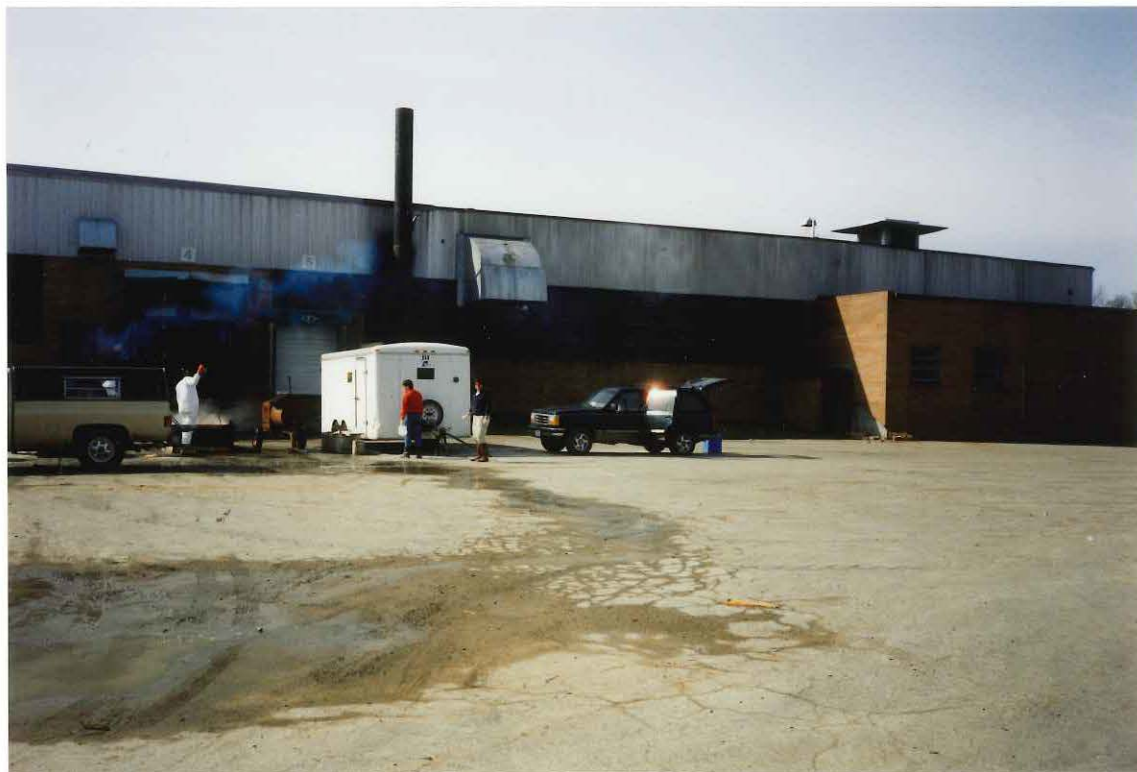
PHOTOGRAPH 9

FACILITY:	Stanley Tools - Fowlerville, Michigan
DATE:	April 18, 1991
TIME:	1050
SUBJECT OF PHOTO:	Decontamination Area.
PHOTOGRAPHER:	Andrew Campbell
CAMERA TYPE:	Fuji DL-30
FILM TYPE:	Kodak Gold 200

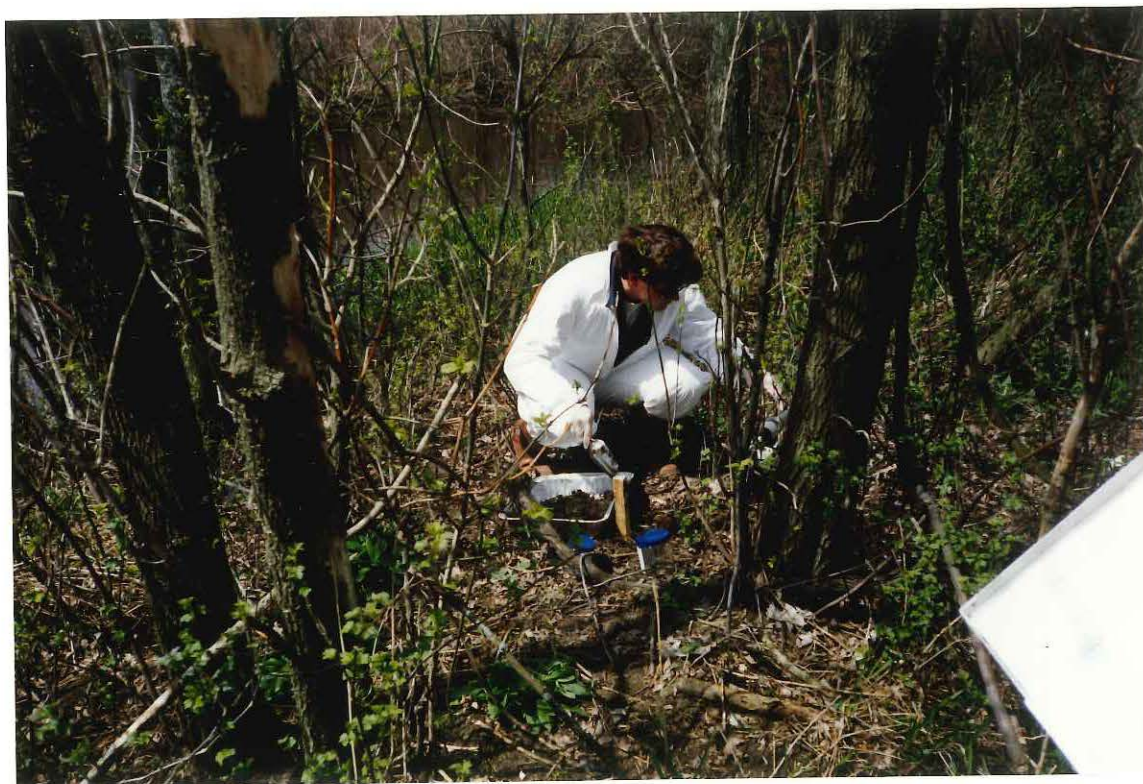
PHOTOGRAPH 10

FACILITY:	Stanley Tools - Fowlerville, Michigan
DATE:	April 18, 1991
TIME:	1300
SUBJECT OF PHOTO:	Dames and Moore personnel sampling bank soil at RC-5.
PHOTOGRAPHER:	Andrew Campbell
CAMERA TYPE:	Fuji DL-30
FILM TYPE:	Kodak Gold 200

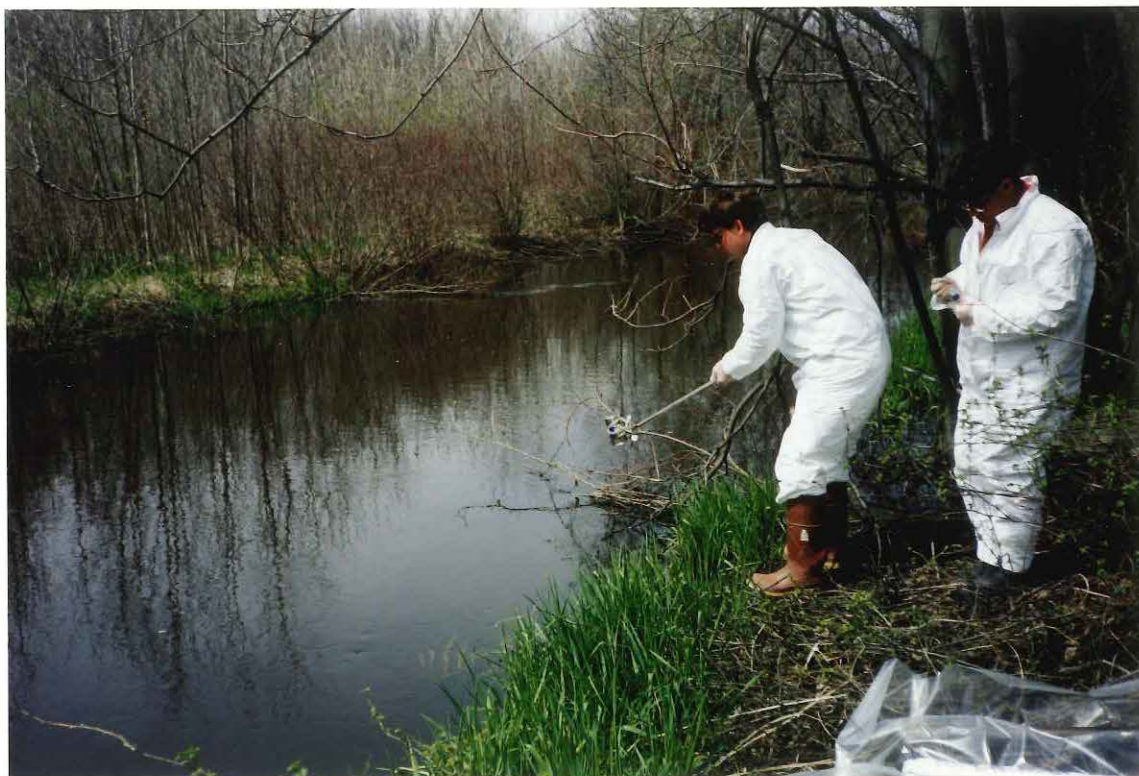
PHOTOGRAPH 11

FACILITY:	Stanley Tools - Fowlerville, Michigan
DATE:	April 18, 1991
TIME:	1315
SUBJECT OF PHOTO:	Dames and Moore personnel collecting surface water sample of RC-5.
PHOTOGRAPHER:	Andrew Campbell
CAMERA TYPE:	Fuji DL-30
FILM TYPE:	Kodak Gold 200

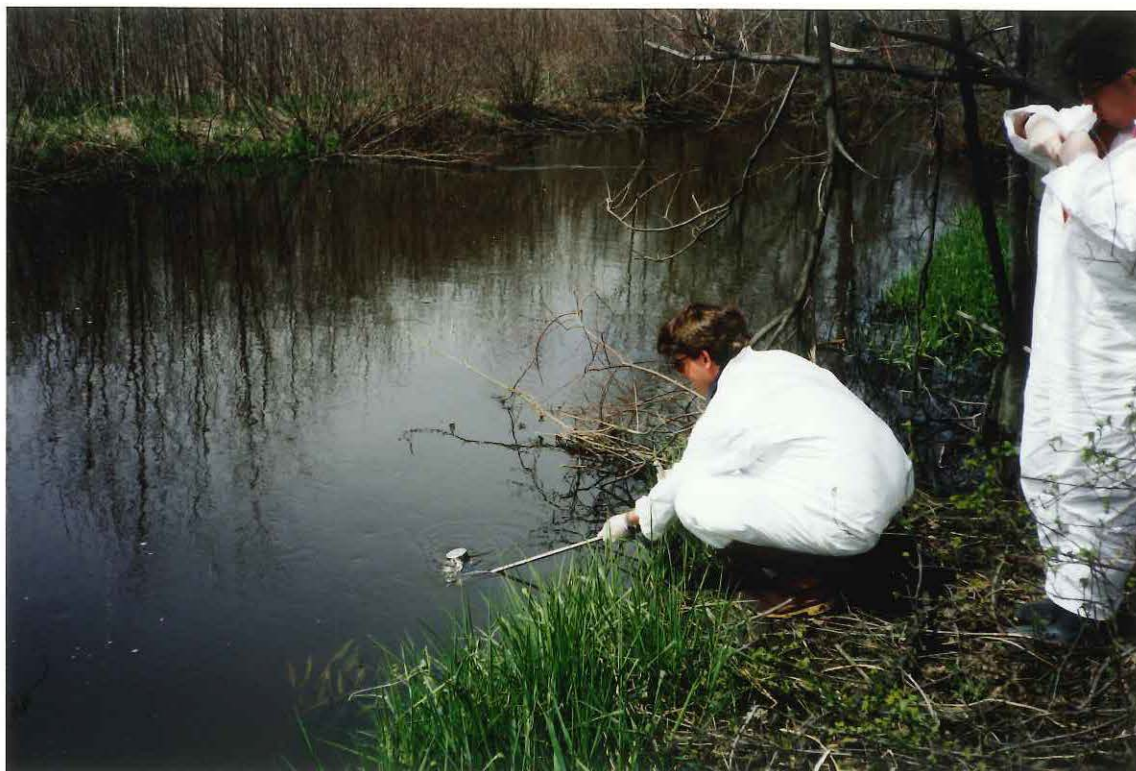
PHOTOGRAPH 12

FACILITY:	Stanley Tools - Fowlerville, Michigan
DATE:	April 18, 1991
TIME:	1315
SUBJECT OF PHOTO:	Dames and Moore personnel collecting surface water sample of RC-5.
PHOTOGRAPHER:	Andrew Campbell
CAMERA TYPE:	Fuji DL-30
FILM TYPE:	Kodak Gold 200

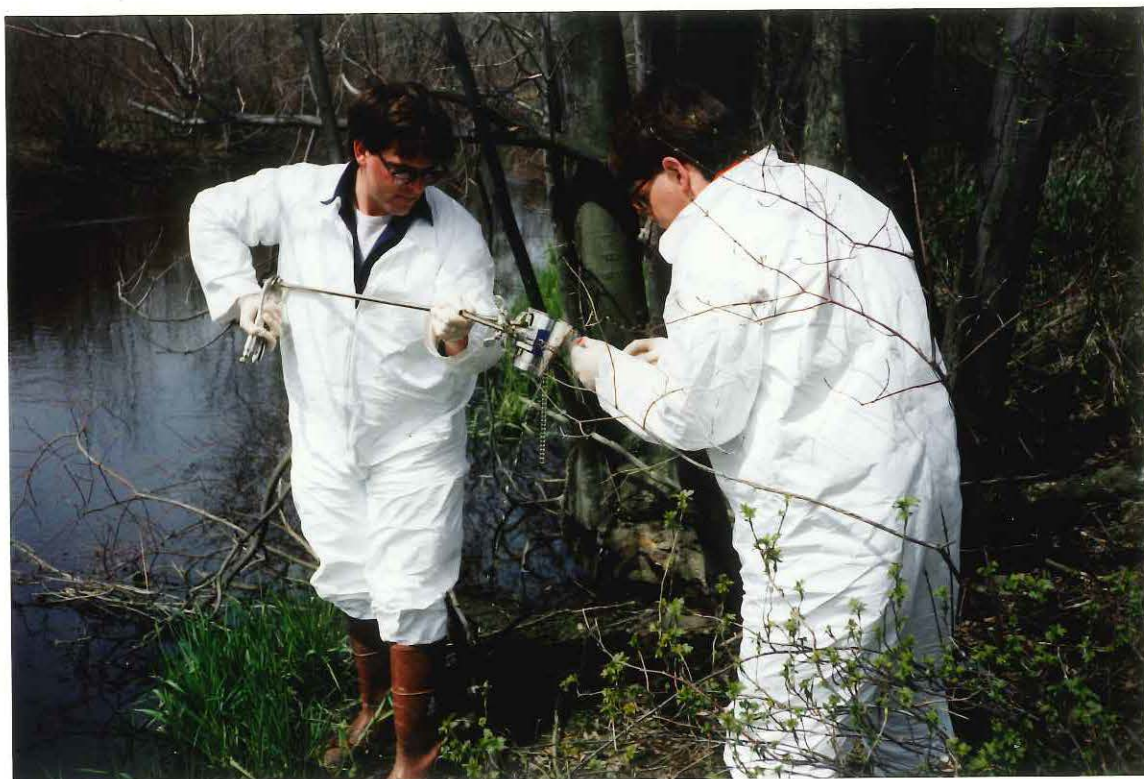
PHOTOGRAPH 13

FACILITY:	Stanley Tools - Fowlerville, Michigan
DATE:	April 18, 1991
TIME:	1315
SUBJECT OF PHOTO:	Dames and Moore personnel collecting surface water sample of RC-5.
PHOTOGRAPHER:	Andrew Campbell
CAMERA TYPE:	Fuji DL-30
FILM TYPE:	Kodak Gold 200

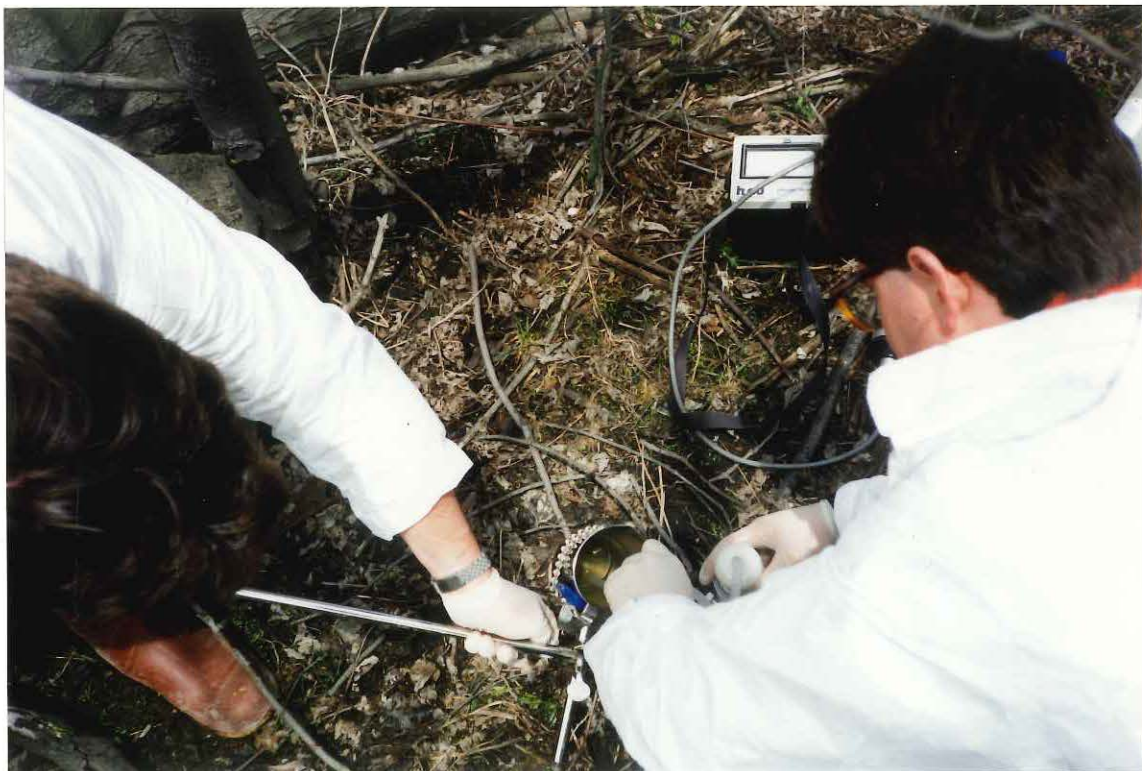
PHOTOGRAPH 14

FACILITY:	Stanley Tools - Fowlerville, Michigan
DATE:	April 18, 1991
TIME:	1315
SUBJECT OF PHOTO:	Dames and Moore personnel collecting surface water sample of RC-5.
PHOTOGRAPHER:	Andrew Campbell
CAMERA TYPE:	Fuji DL-30
FILM TYPE:	Kodak Gold 200

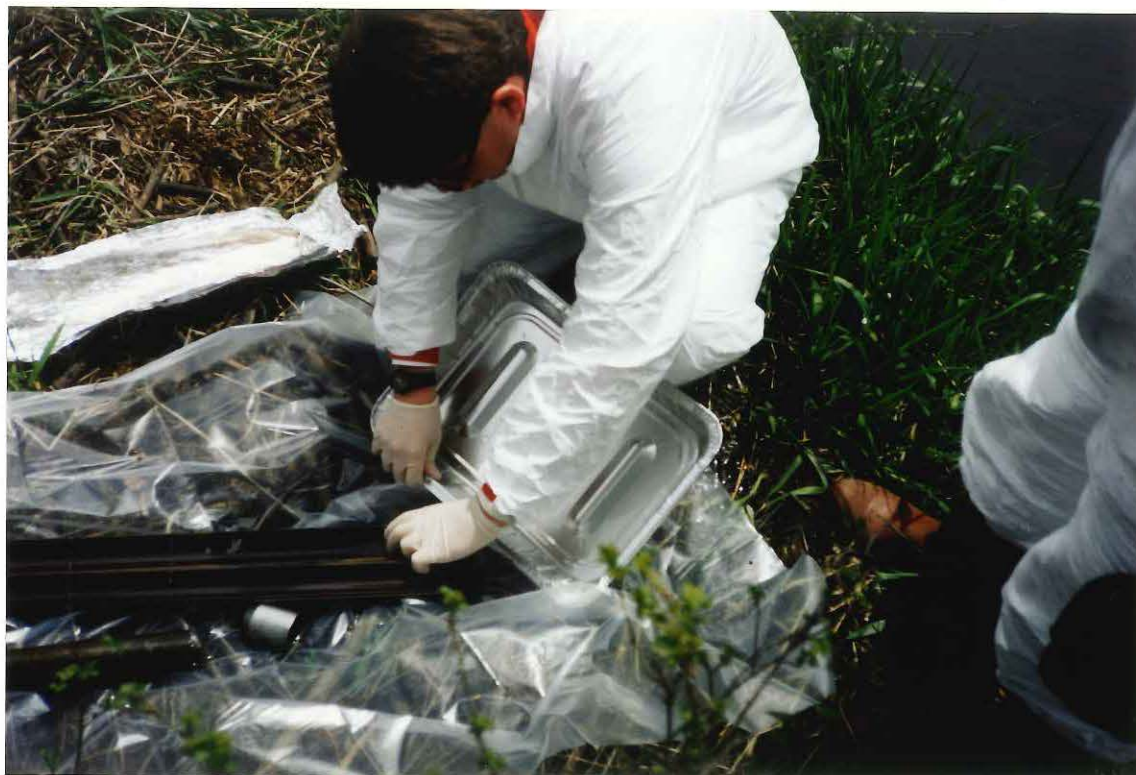
PHOTOGRAPH 16

FACILITY:	Stanley Tools - Fowlerville, Michigan
DATE:	April 18, 1991
TIME:	1340
SUBJECT OF PHOTO:	Dames and Moore collecting river sediment sample at RC-5.
PHOTOGRAPHER:	Andrew Campbell
CAMERA TYPE:	Fuji DL-30
FILM TYPE:	Kodak Gold 200

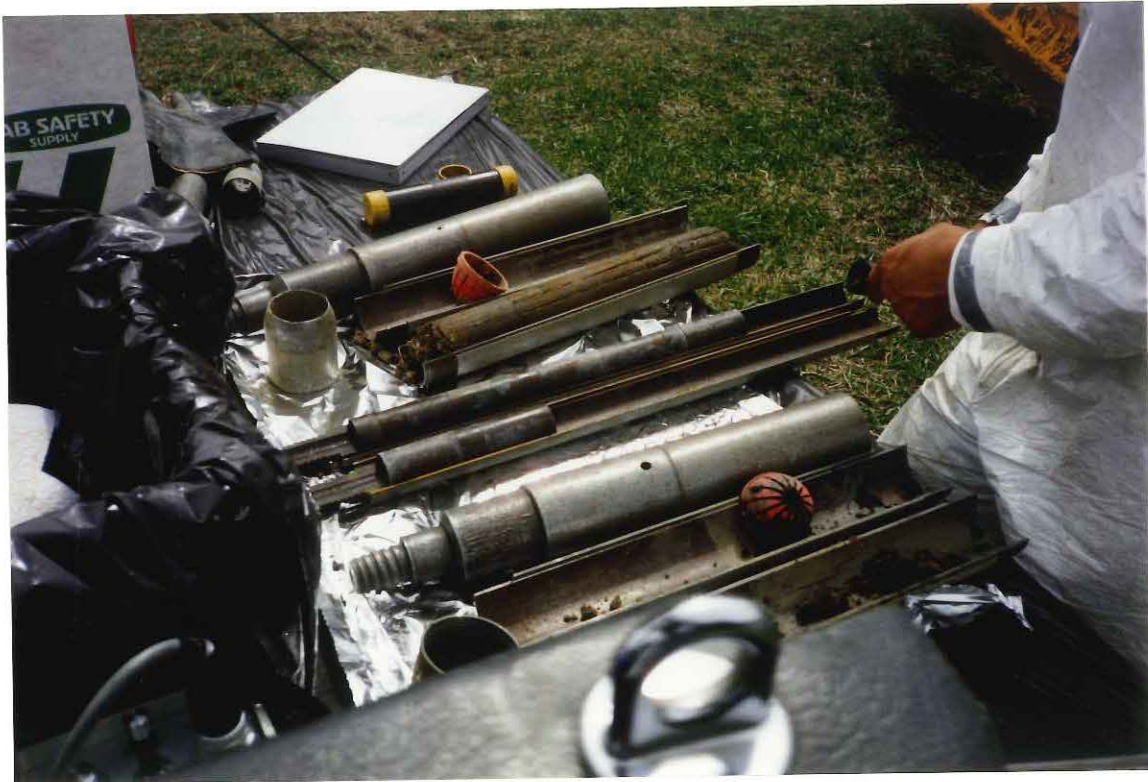
PHOTOGRAPH 17

FACILITY:	Stanley Tools - Fowlerville, Michigan
DATE:	April 18, 1991
TIME:	1340
SUBJECT OF PHOTO:	Dames and Moore collecting river sediment sample at RC-5.
PHOTOGRAPHER:	Andrew Campbell
CAMERA TYPE:	Fuji DL-30
FILM TYPE:	Kodak Gold 200

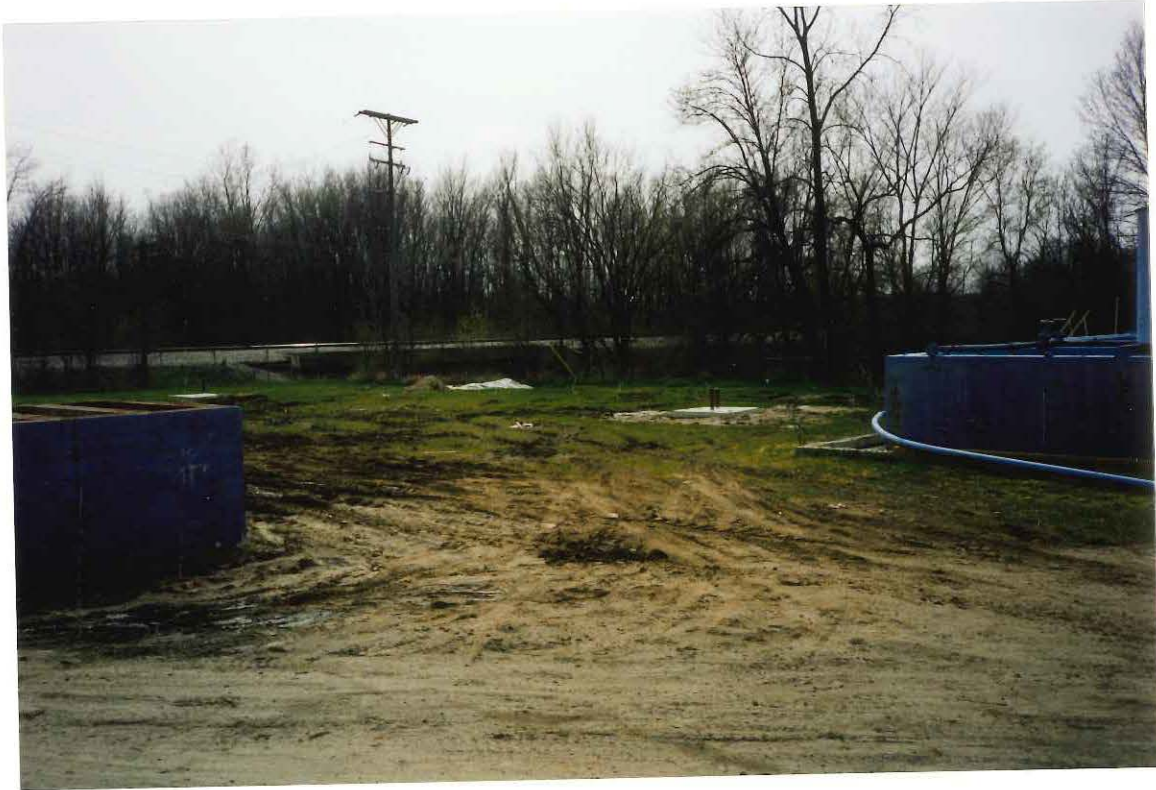
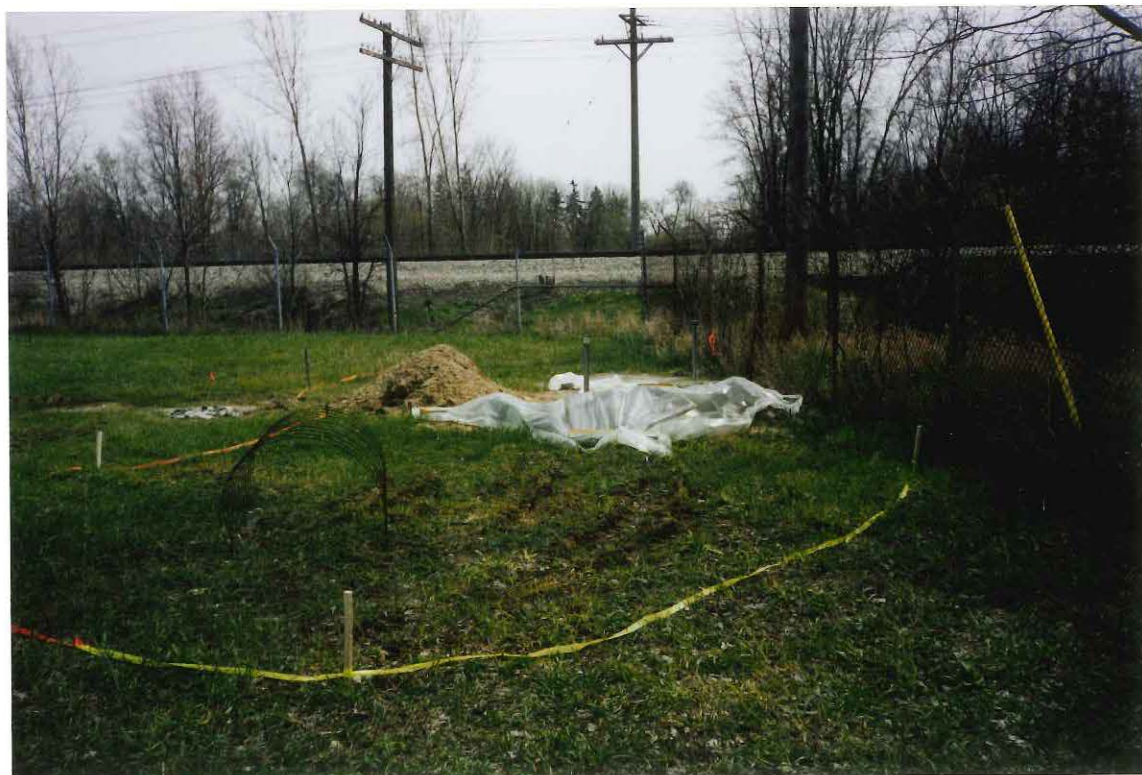
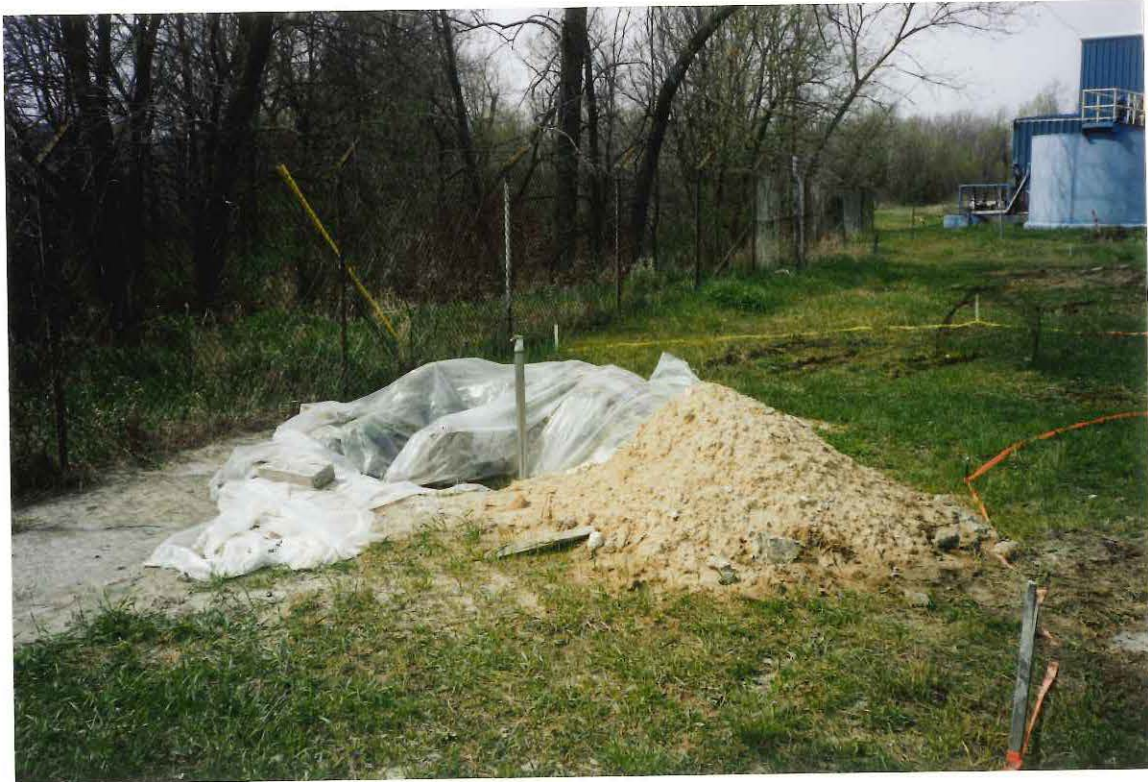
PHOTOGRAPH 18

FACILITY:	Stanley Tools - Fowlerville, Michigan
DATE:	April 18, 1991
TIME:	1600
SUBJECT OF PHOTO:	Area B - location where buried drums were found.
PHOTOGRAPHER:	Andrew Campbell
CAMERA TYPE:	Fuji DL-30
FILM TYPE:	Kodak Gold 200

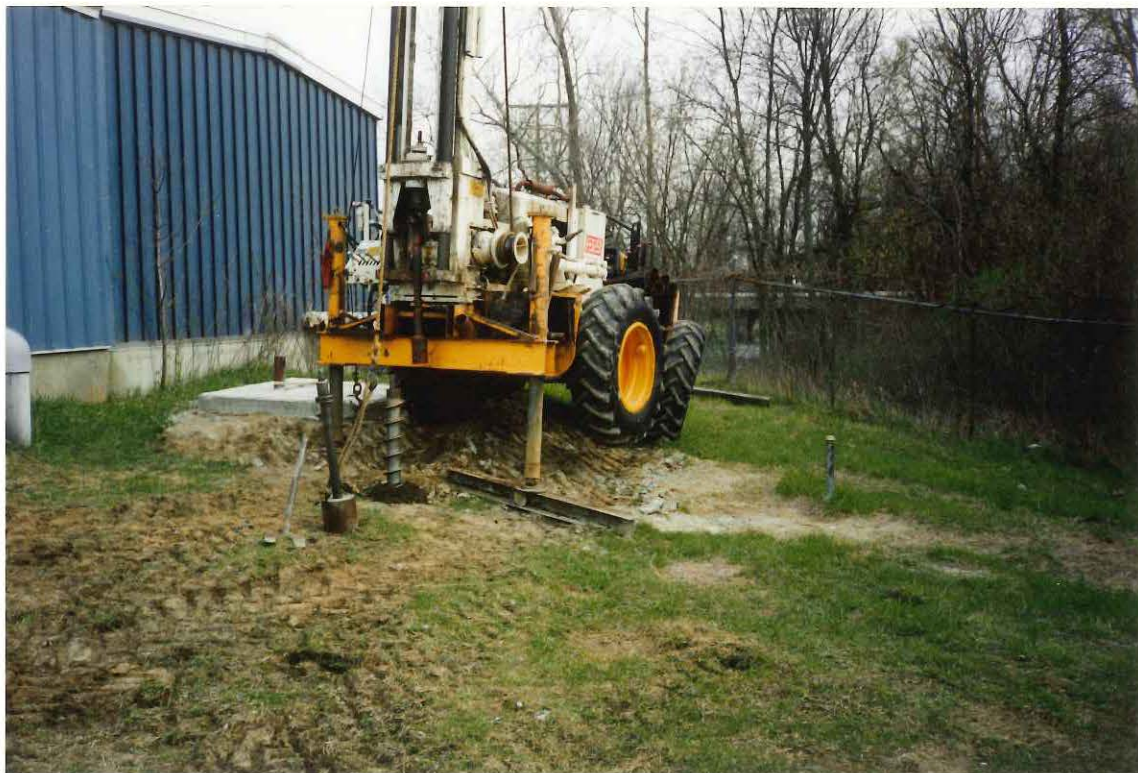
PHOTOGRAPH 21

FACILITY:	Stanley Tools - Fowlerville, Michigan
DATE:	April 18, 1991
TIME:	1710
SUBJECT OF PHOTO:	Drilling set up at J-1.
PHOTOGRAPHER:	Andrew Campbell
CAMERA TYPE:	Fuji DL-30
FILM TYPE:	Kodak Gold 200

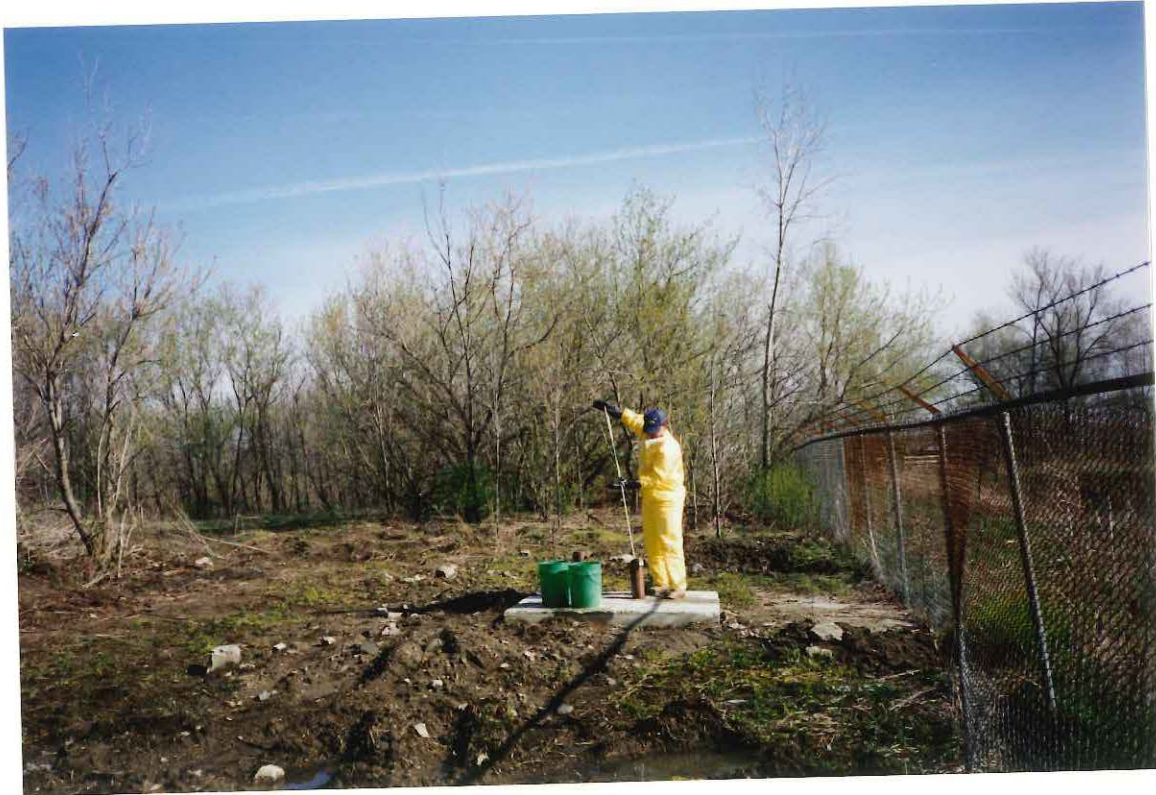
PHOTOGRAPH 22

FACILITY:	Stanley Tools - Fowlerville, Michigan
DATE:	April 25, 1991
TIME:	0940
SUBJECT OF PHOTO:	Dames and Moore personnel purging MW-A1.
PHOTOGRAPHER:	Andrew Campbell
CAMERA TYPE:	Fuji DL-30
FILM TYPE:	Kodak Gold 200

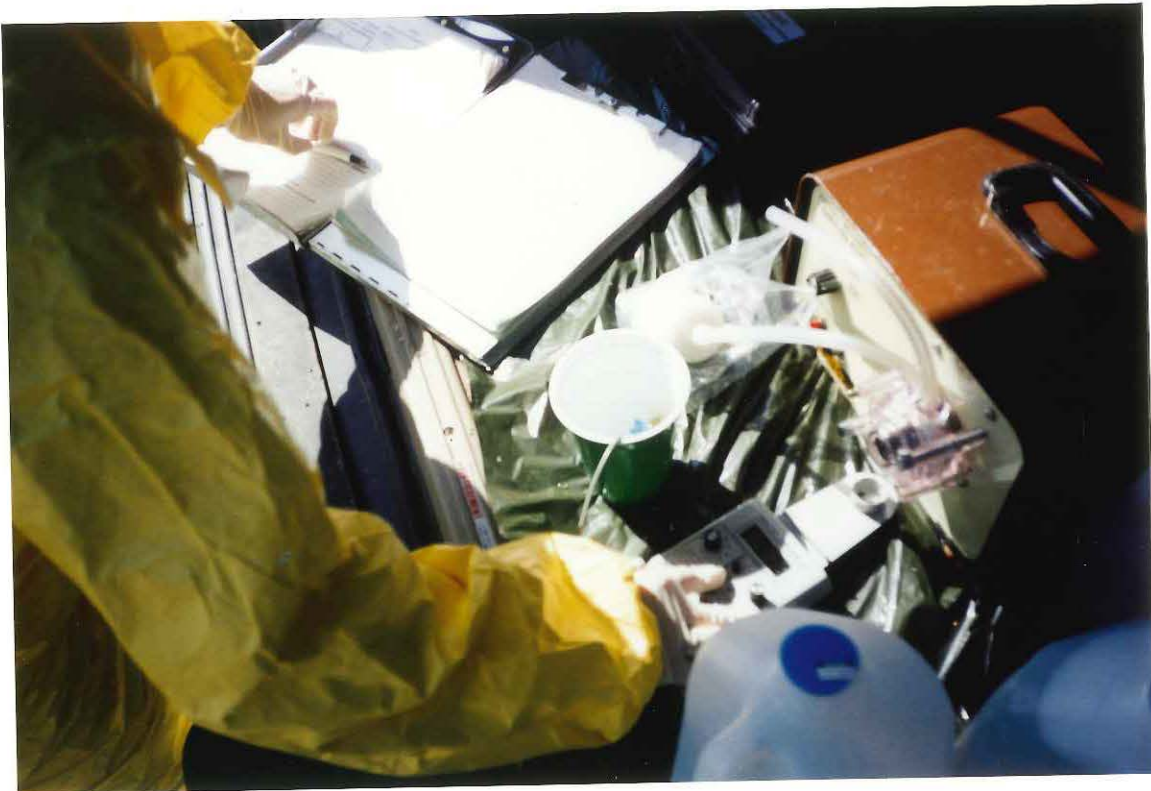
PHOTOGRAPH 24

FACILITY:	Stanley Tools - Fowlerville, Michigan
DATE:	April 25, 1991
TIME:	1000
SUBJECT OF PHOTO:	Dames and Moore taking field parameters at MW-A1.
PHOTOGRAPHER:	Andrew Campbell
CAMERA TYPE:	Fuji DL-30
FILM TYPE:	Kodak Gold 200

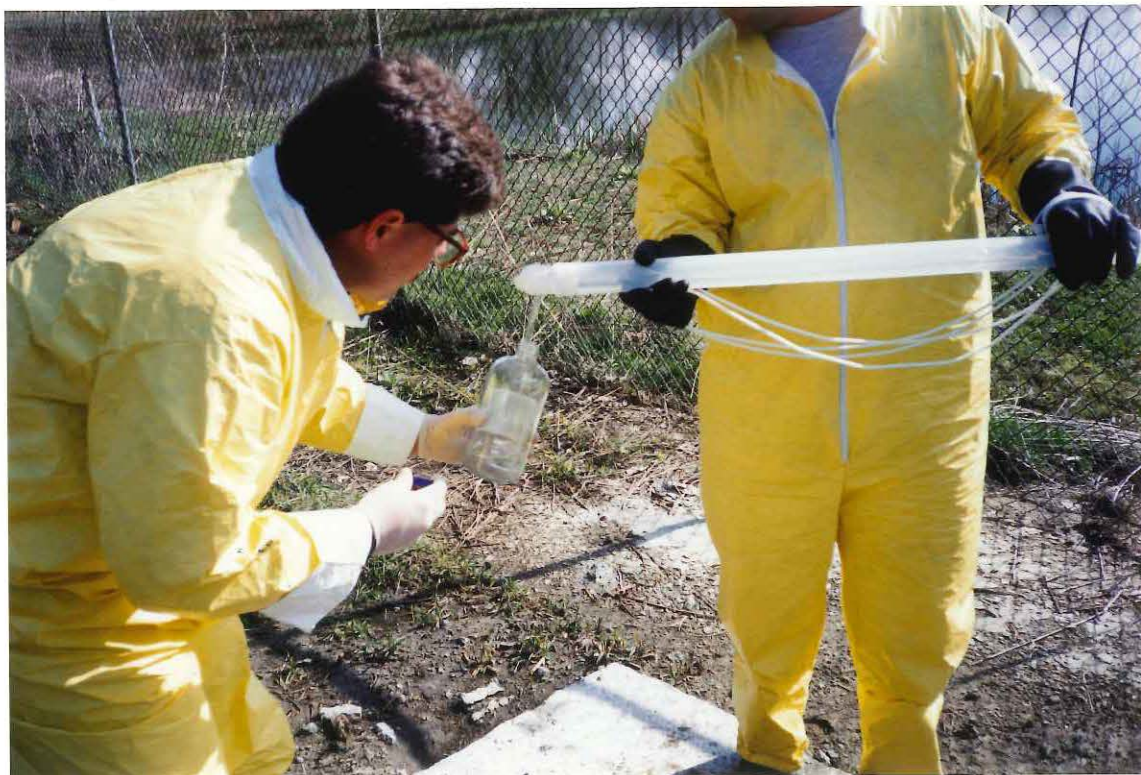
PHOTOGRAPH 26

FACILITY:	Stanley Tools - Fowlerville, Michigan
DATE:	April 25, 1991
TIME:	1005
SUBJECT OF PHOTO:	Dames and Moore personnel collecting sample at MW-A1.
PHOTOGRAPHER:	Andrew Campbell
CAMERA TYPE:	Fuji DL-30
FILM TYPE:	Kodak Gold 200

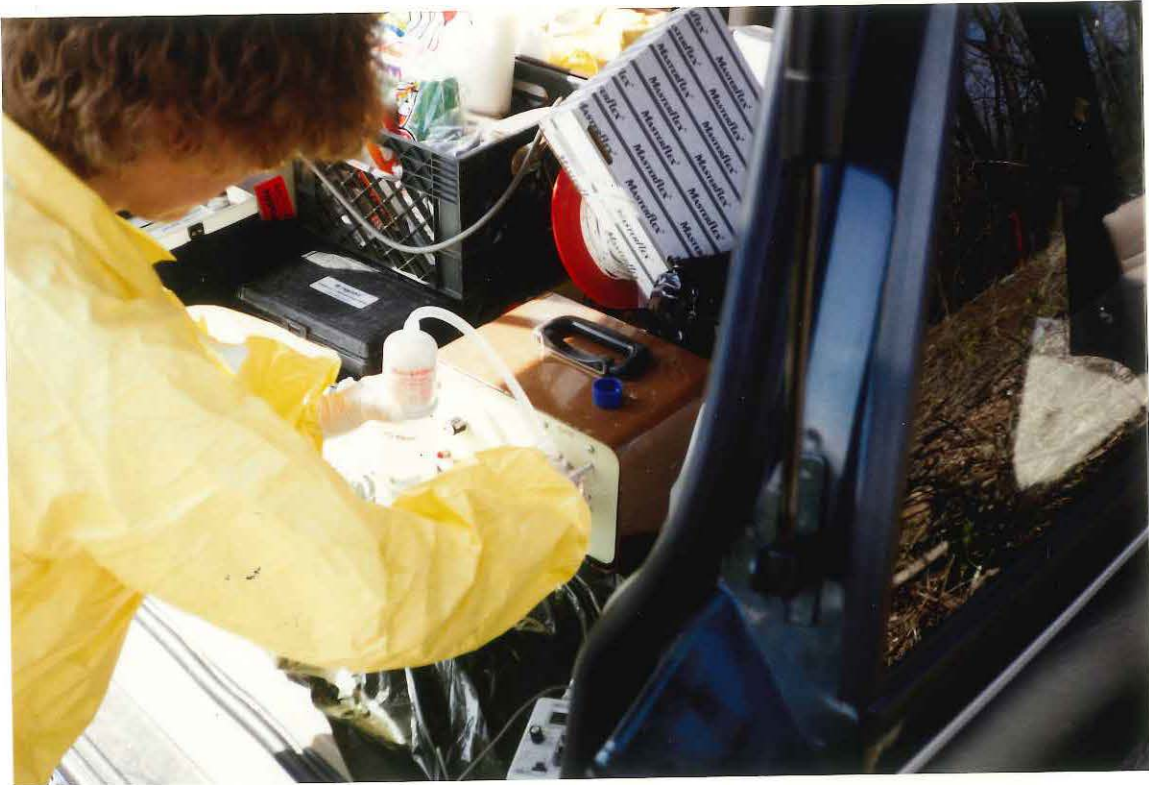
PHOTOGRAPH 27

FACILITY:	Stanley Tools - Fowlerville, Michigan
DATE:	April 25, 1991
TIME:	1015
SUBJECT OF PHOTO:	Dames and Moore personnel field filtering sample at MW-A1.
PHOTOGRAPHER:	Andrew Campbell
CAMERA TYPE:	Fuji DL-30
FILM TYPE:	Kodak Gold 200

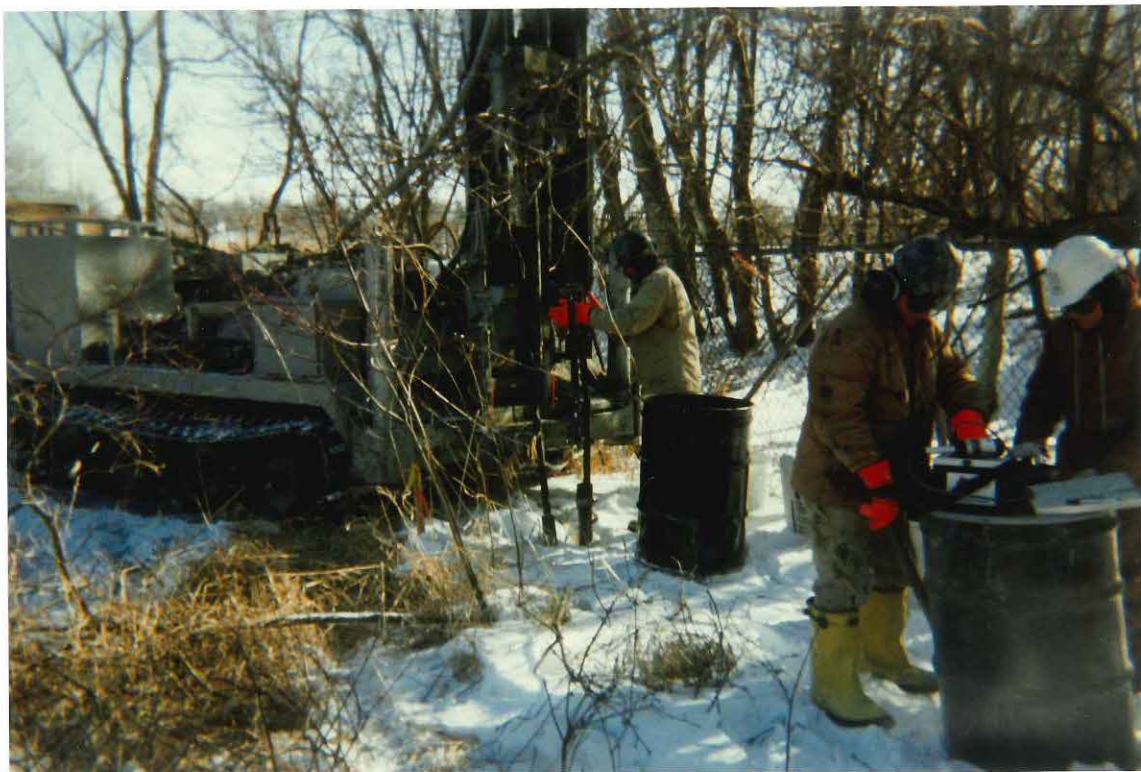
PHOTOGRAPH #35

LOCATION:	Stanley Tools, Fowlerville, MI
DATE:	1/26/94
TIME:	1220
SUBJECT:	Advancing split-spoon at GB-30.

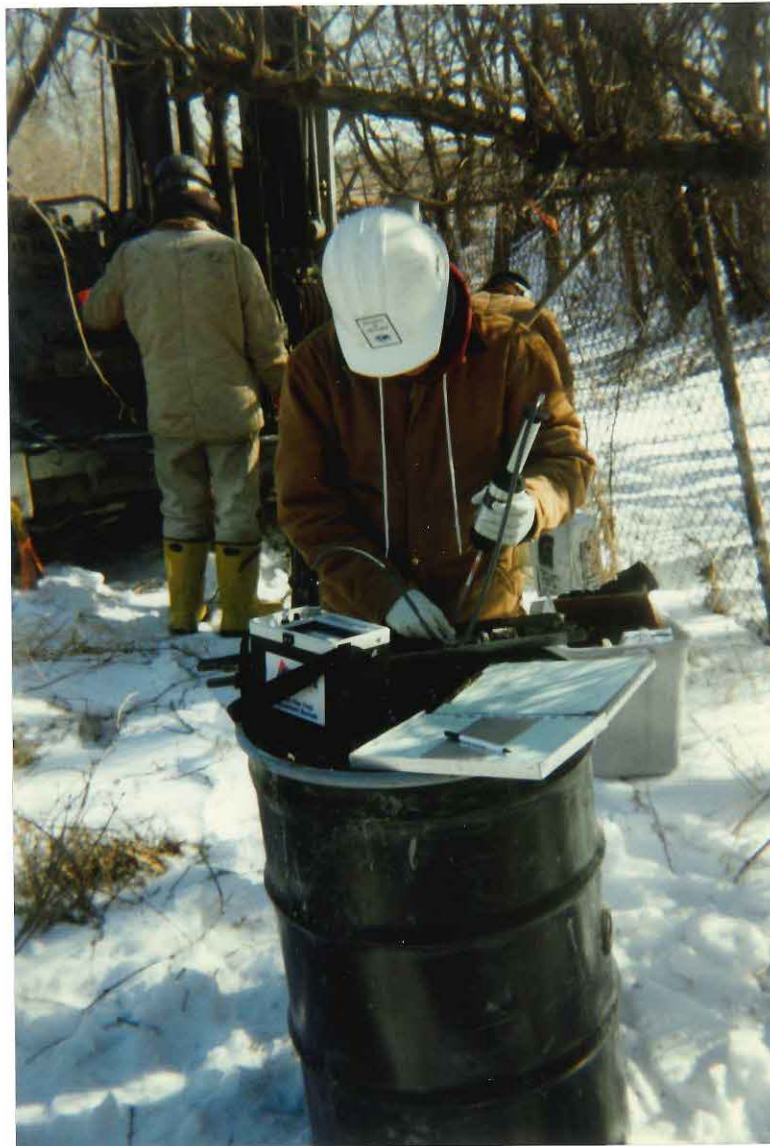
PHOTOGRAPH #36

LOCATION:	Stanley Tools, Fowlerville, MI
DATE:	1/26/94
TIME:	1225
SUBJECT:	Logging split-spoon at GB-30.

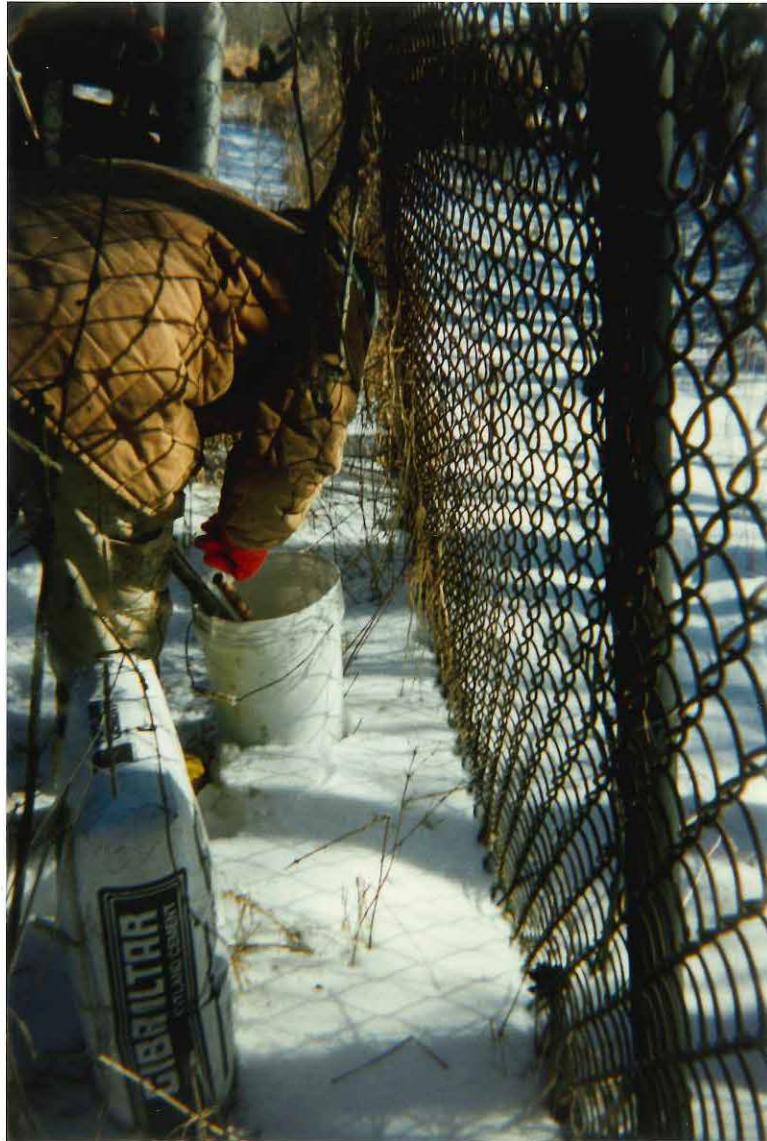
PHOTOGRAPH #37

LOCATION:	Stanley Tools, Fowlerville, MI
DATE:	1/26/94
TIME:	1225
SUBJECT:	Drillers performing initial decon on split-spoon.
